**[Client Name]**  
**Final Energy Assessment Report**  
**[Date]**

On [date], Sarah Lynn Cunningham, PE, and Monique Tilford of the Louisville Climate Action Network (LCAN) visited the [client church] (CC) campus to assess opportunities for the congregation to “spend less on utilities, more on mission.”

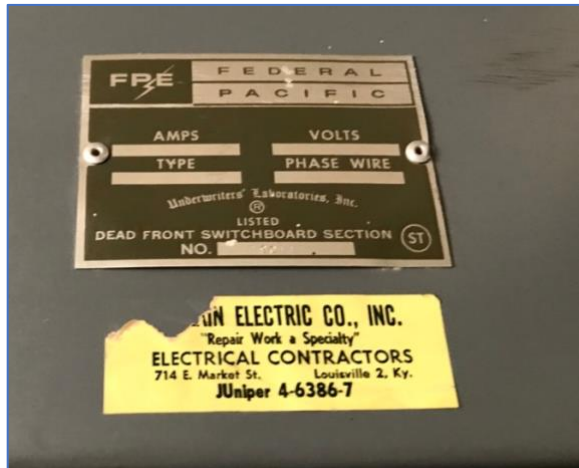
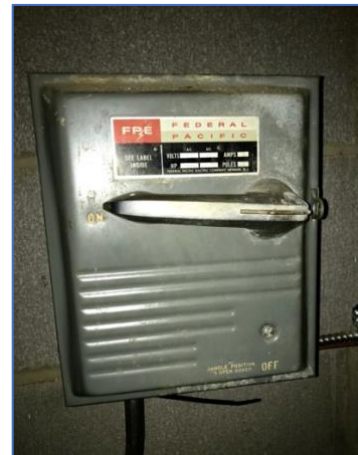
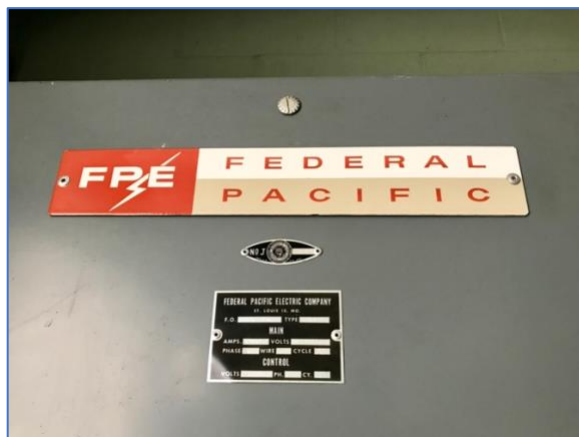
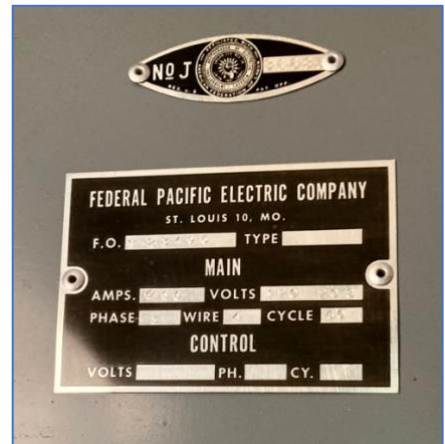
3. Have all electrical panels manufactured by Federal Pacific, Inc., inspected to determine whether they are the type that start fires.<sup>4</sup>

4. Locate and repair the sources of water leaking into the sanctuary, the FLC's ridge vent and mechanical room and anywhere else they appear.<sup>5</sup>

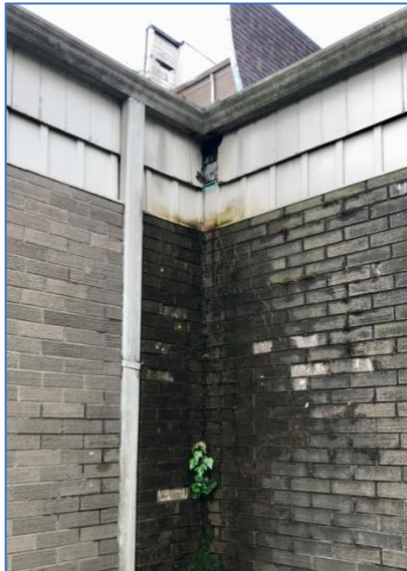
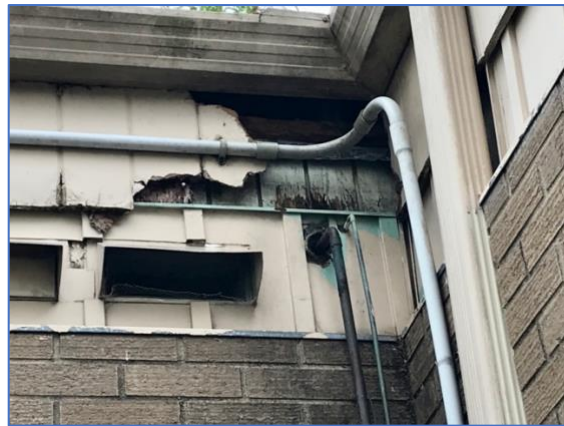
1. Patch or cap the gaps and abandoned pipe penetrations in the East Wing soffits, after filling with hand-held spray foam insulation, e.g., Great Stuff®, as applicable. While there, clean any gutters containing leaf debris and adjust or add taller splashguards to prevent roof runoff from overflowing the guttering and sending water down exterior walls.

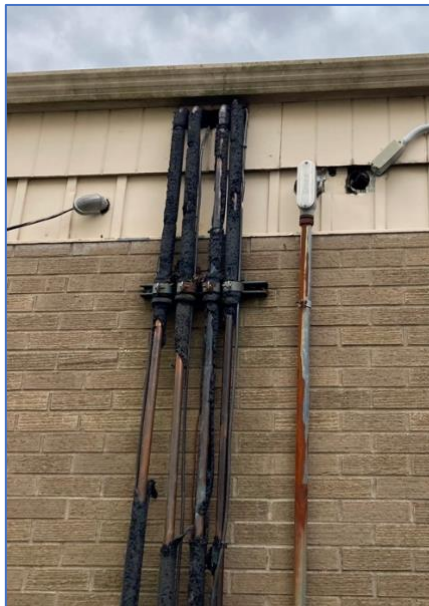
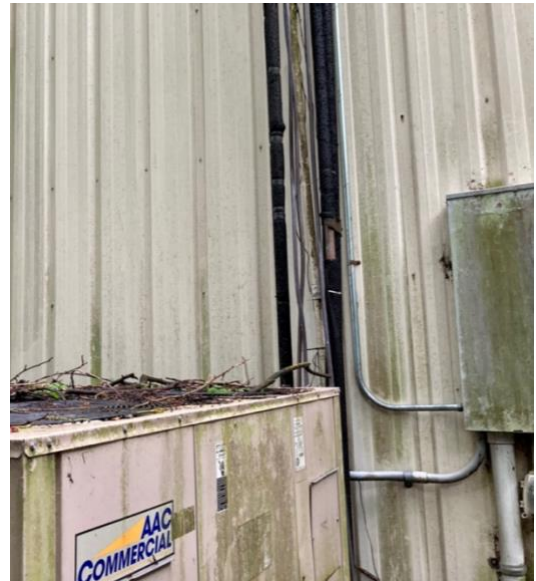
1. Replace all compromised or missing insulation on piping between exterior AC units and indoor spaces with properly sized, rubber pipe wrap. Replace, too, the insulation in the southeast corner of the gym's ground floor, near the base of the stairwell. We recommend a closed-cell-foam product, e.g., Armaflex<sup>®</sup>. Seal joints well with the manufacturer's recommended adhesive (aka "dope").

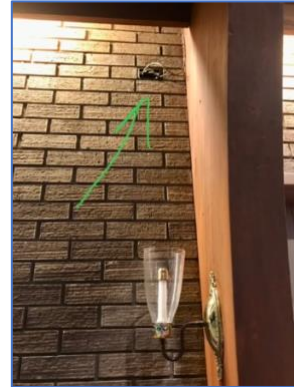
1. Find a custom cover or modify a standard cover for the open electrical box in the sanctuary (right).
2. Investigate options for reducing monthly service charges on LG&E bills. First, determine whether any equipment in use requires three-phase power:
  - a. If not, determine the practicality, costs and payback of changing the three-phase service to single-phase to save \$675/year.
  - b. If three-phase power continues to be required, investigate the practicality, costs and payback of merging the single-phase meter with the three-phase meter to save \$423/year incurred by the single-phase meter.

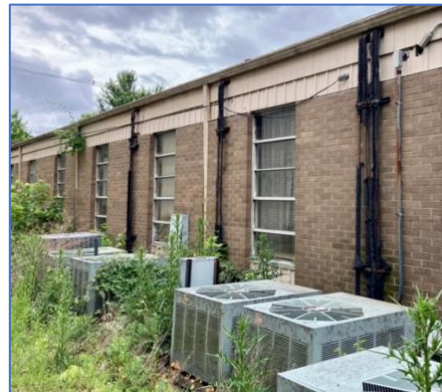
1. Evaluate the current necessity of the five existing outdoor lights, such as near the concession stand and ballpark. (LG&E rates for restoring service are reasonable if you were to change your mind later.)<sup>10</sup>
2. Remove weeds growing within at least 3-ft space around all outdoor AC units, such as outside the East wing (right). Remove dead plant debris accumulated atop AC units.

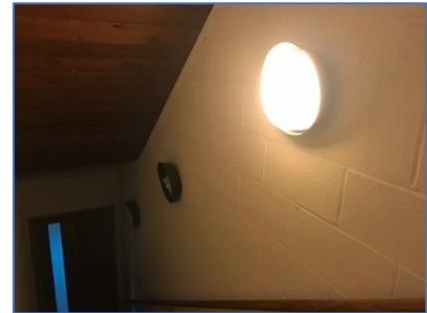
- a. Nine spent CFLs in the sanctuary
- b. The three lights in the stairwell to the choir loft (right)
- c. Ceiling lamps in the choir loft
- d. Ceiling lamps in the original vestibule
